Safety Inspection Report

Annual Inspection

Maes y Dre Recreation Grounds

Welshpool Town Council

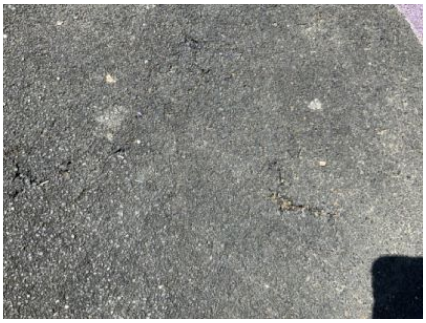
The surface is cracking.

Repair.
