Safety Inspection Report

Annual Inspection

Burgess Park Junior

24 June 2026

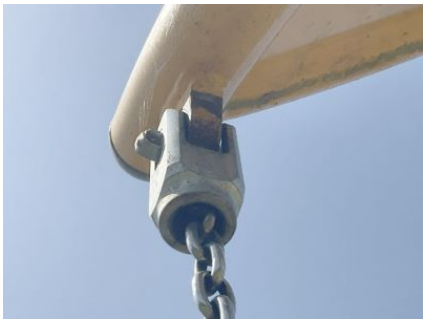
Description

There is wear in the bushes.

Risk score: 5

Remove shackle bolt and check bush and shackle pin wear, replacing as necessary.

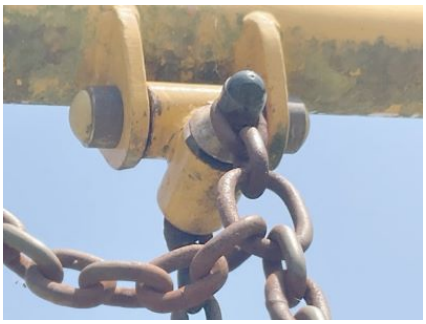
The supporting components should be dismantled and inspected according to the manufacturer's instructions. This will need doing on a regular basis, as defined by the manufacturer. This can lead to a high risk if no action is taken.

4

Cannot assess condition of top chain links without dismantling.

Dismantle and inspect according to manufacturer's instructions.
